# Comprehensive Campus Study

## Baseline Conditions - Southbury Training School

Southbury Training School Task Force and Office of the First Selectman | December 4, 2013

This is a baseline study to provide information about the current infrastructure and natural resource features of the Southbury Training School. The information included has not been based on any assumptions as to the future use of the property.

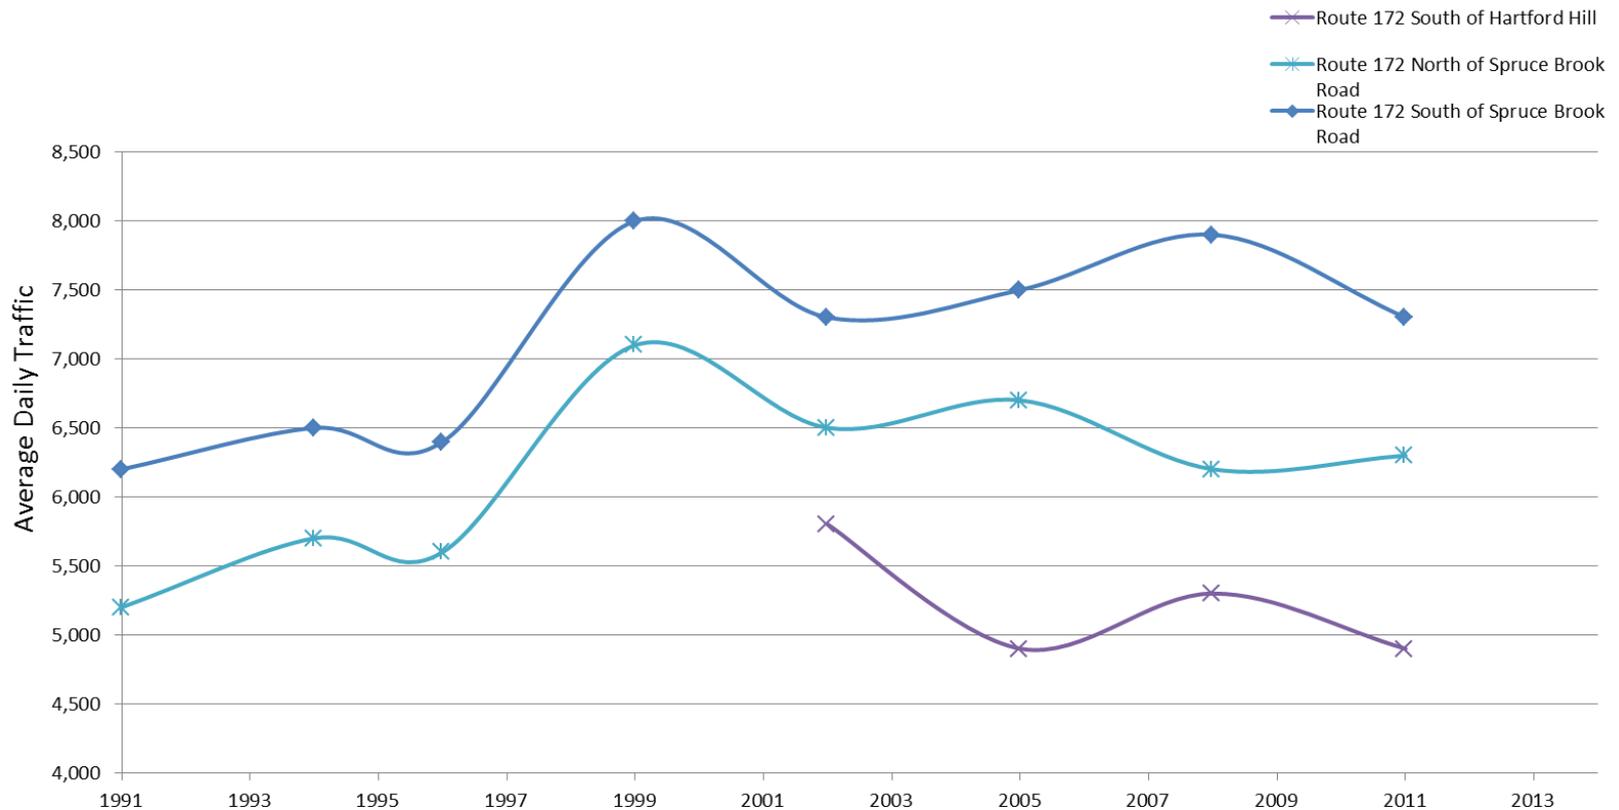
- Traffic volumes for the area have held steady since it peaked in 1999

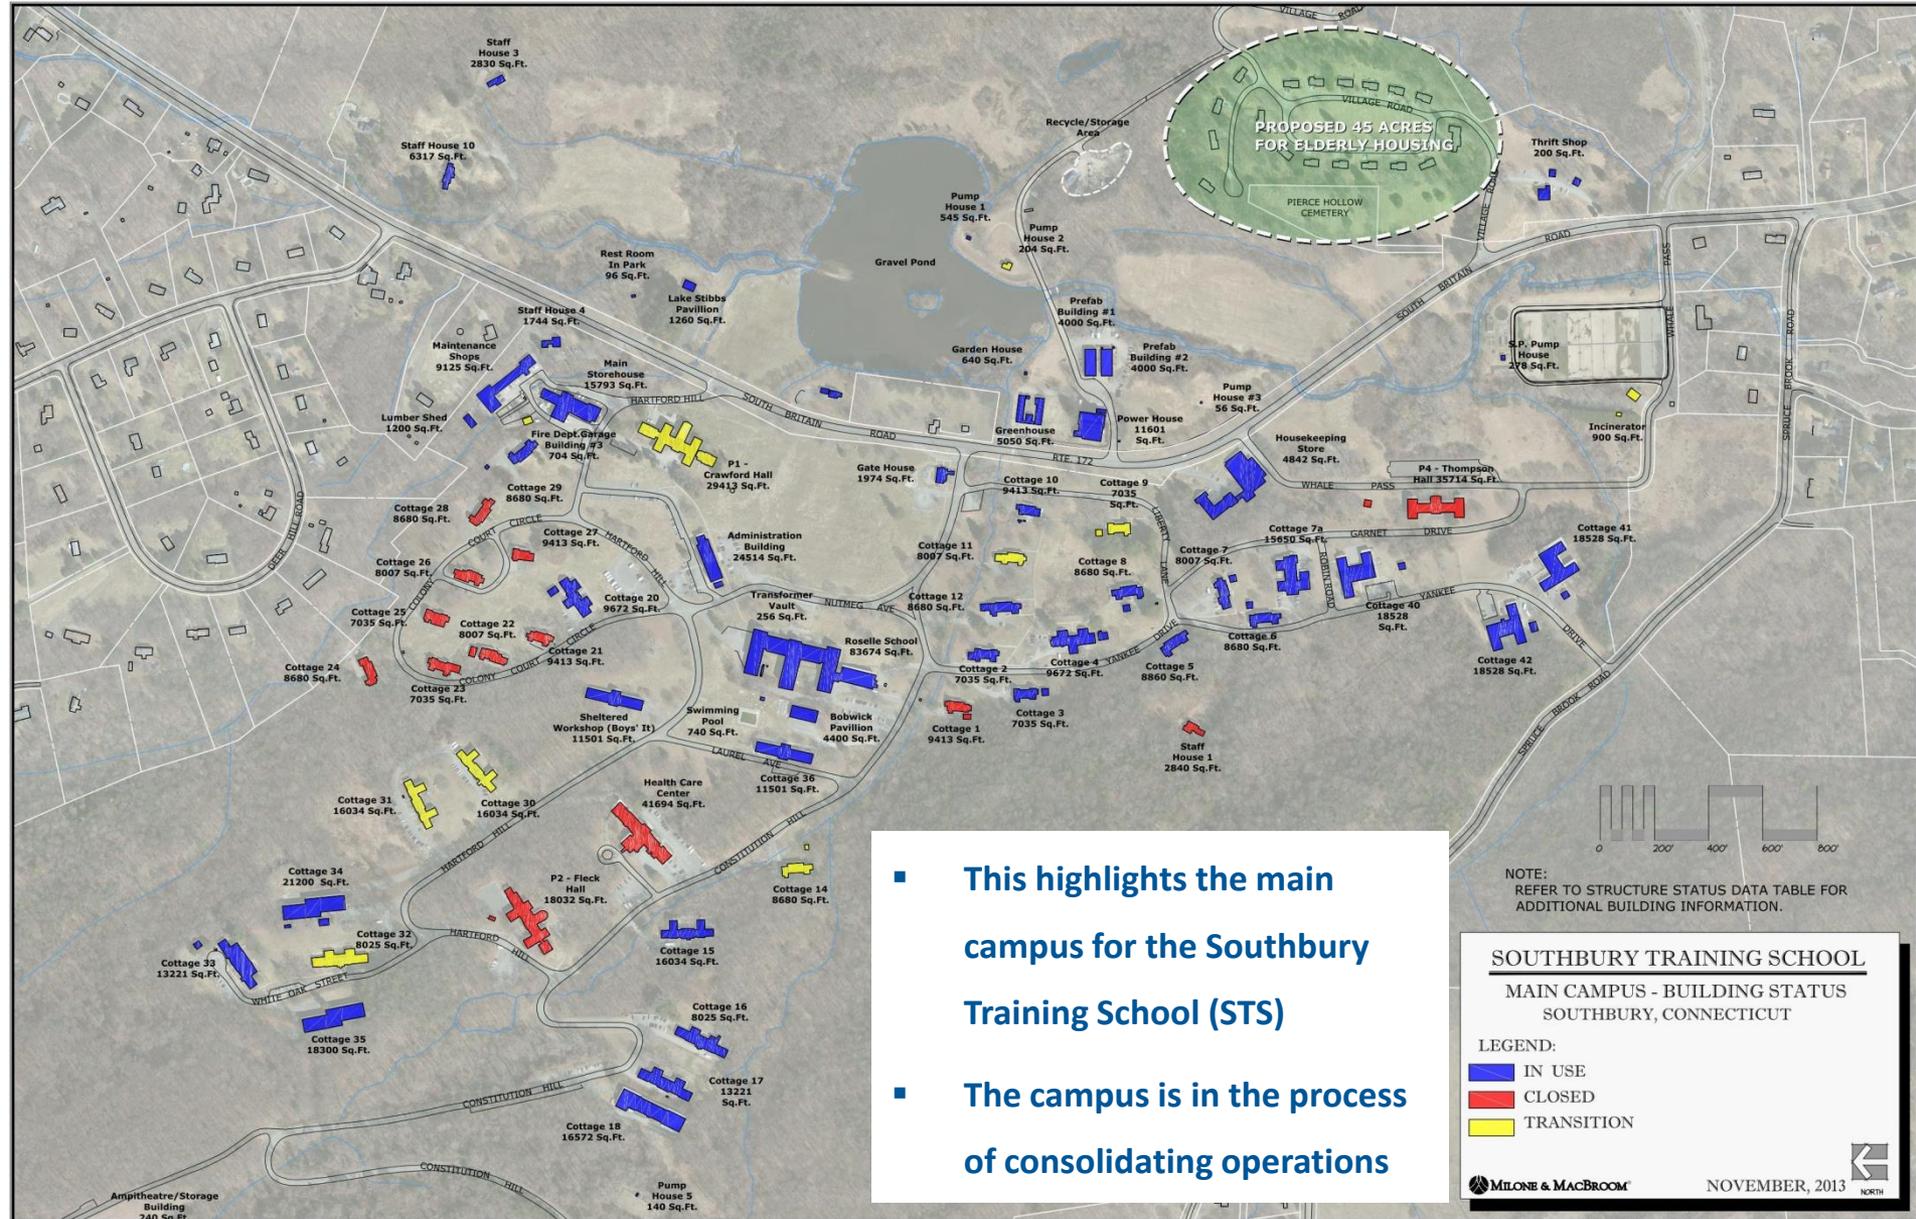
**SOUTHBURY TRAINING SCHOOL**  
MAIN CAMPUS - BUILDING STATUS  
SOUTHBURY, CONNECTICUT

- This highlights the main campus for the Southbury Training School (STS)
- The campus is in the process of consolidating operations

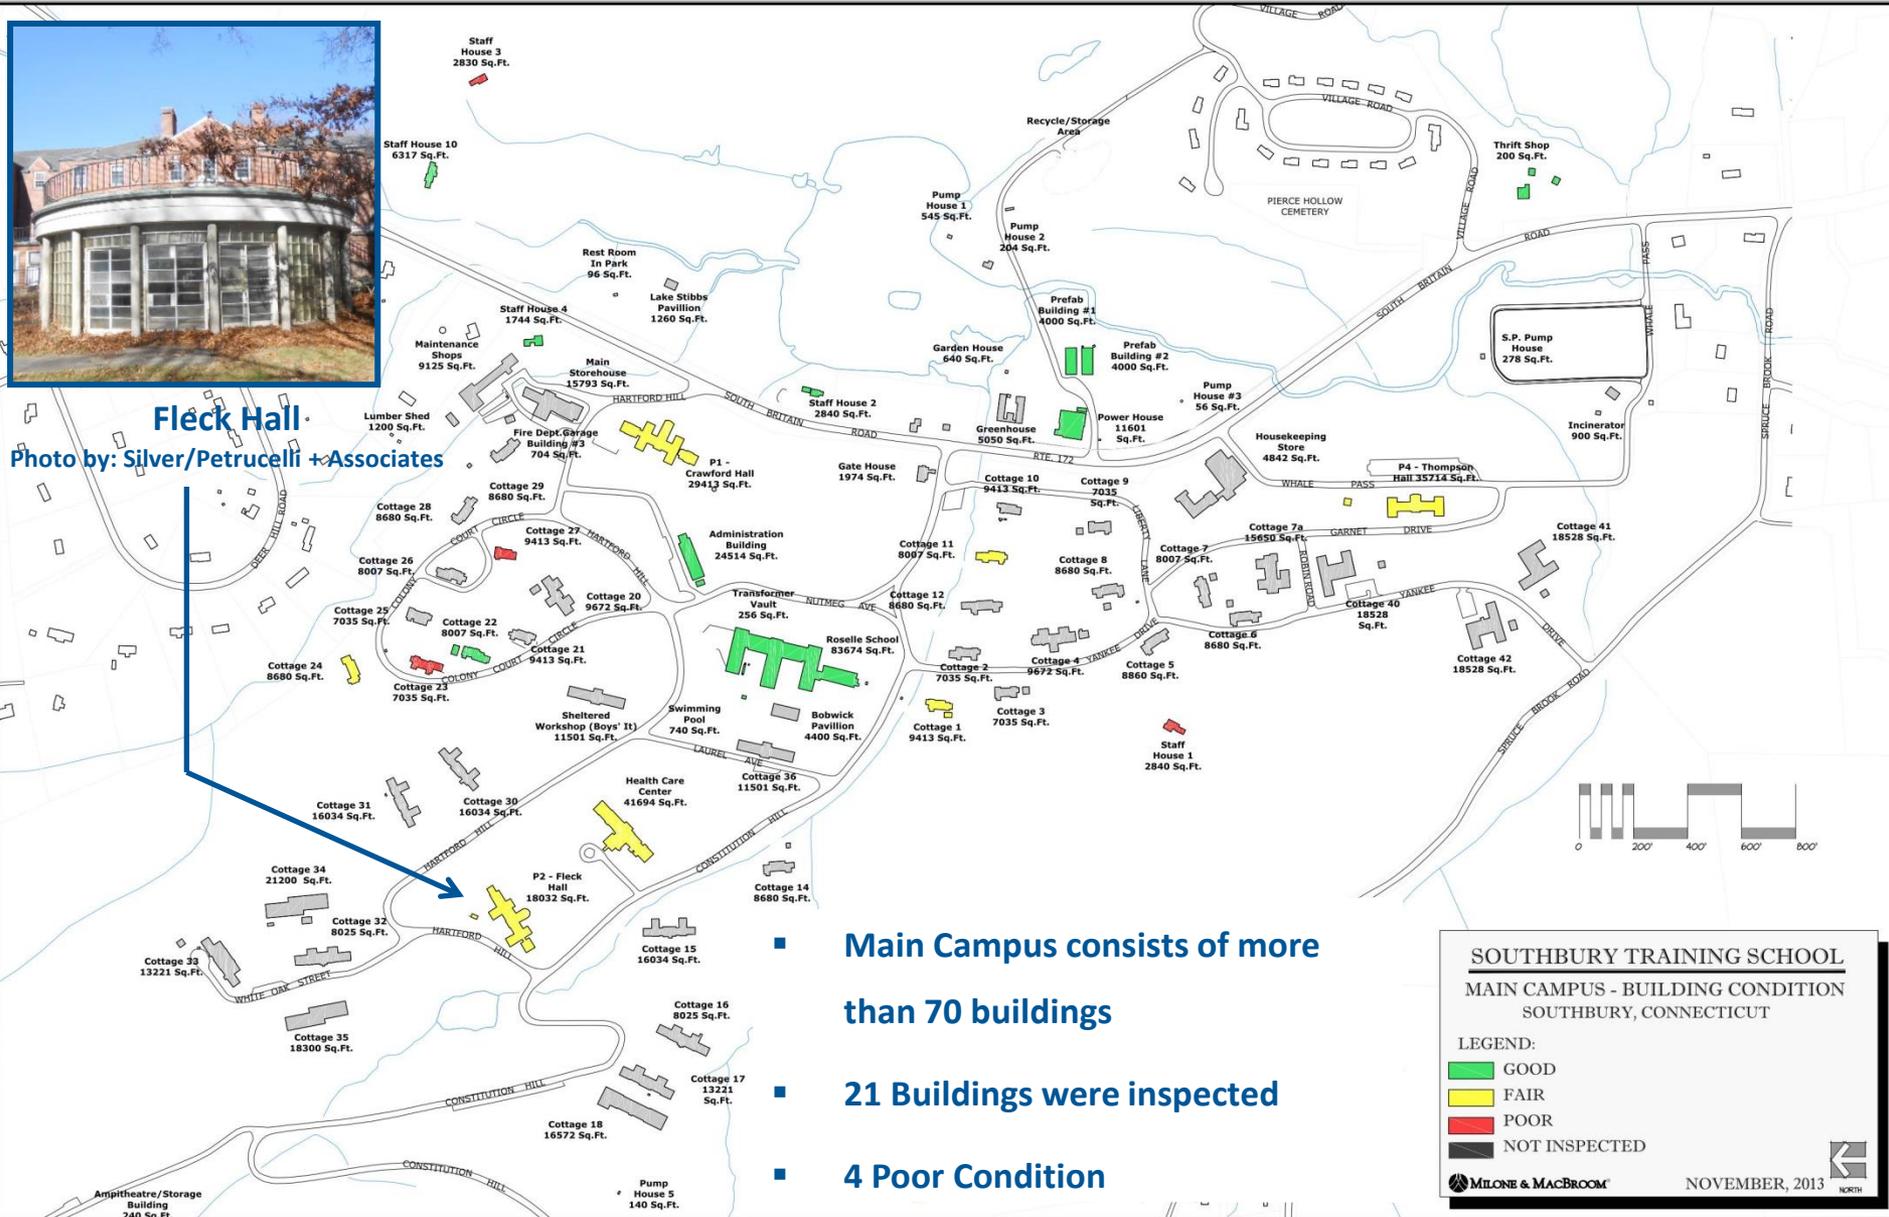
# Building Conditions

- Main Campus consists of more than 70 buildings
- 21 Buildings were inspected
- 4 Poor Condition

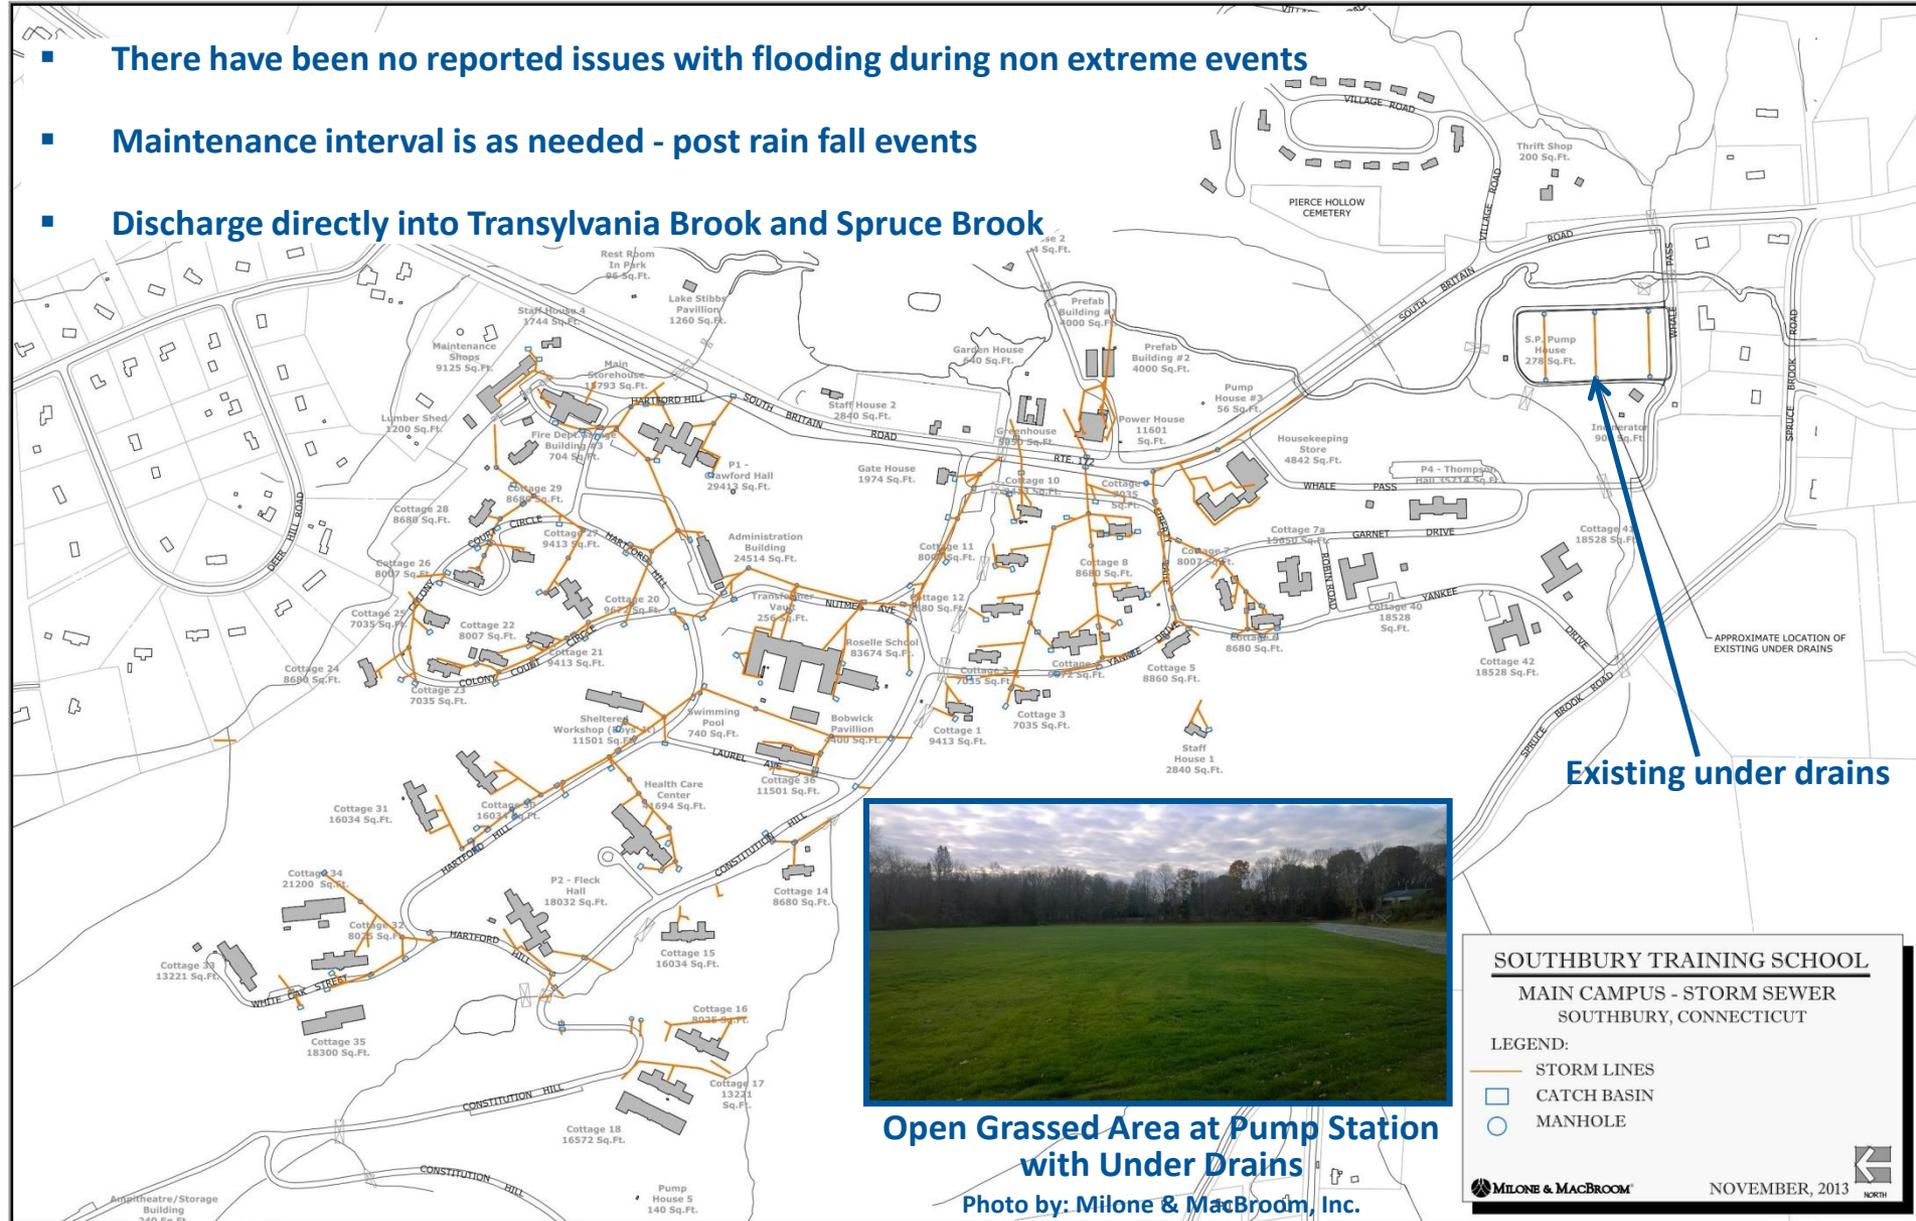
# Site Drainage System

- There have been no reported issues with flooding during non extreme events
- Maintenance interval is as needed - post rain fall events
- Discharge directly into Transylvania Brook and Spruce Brook

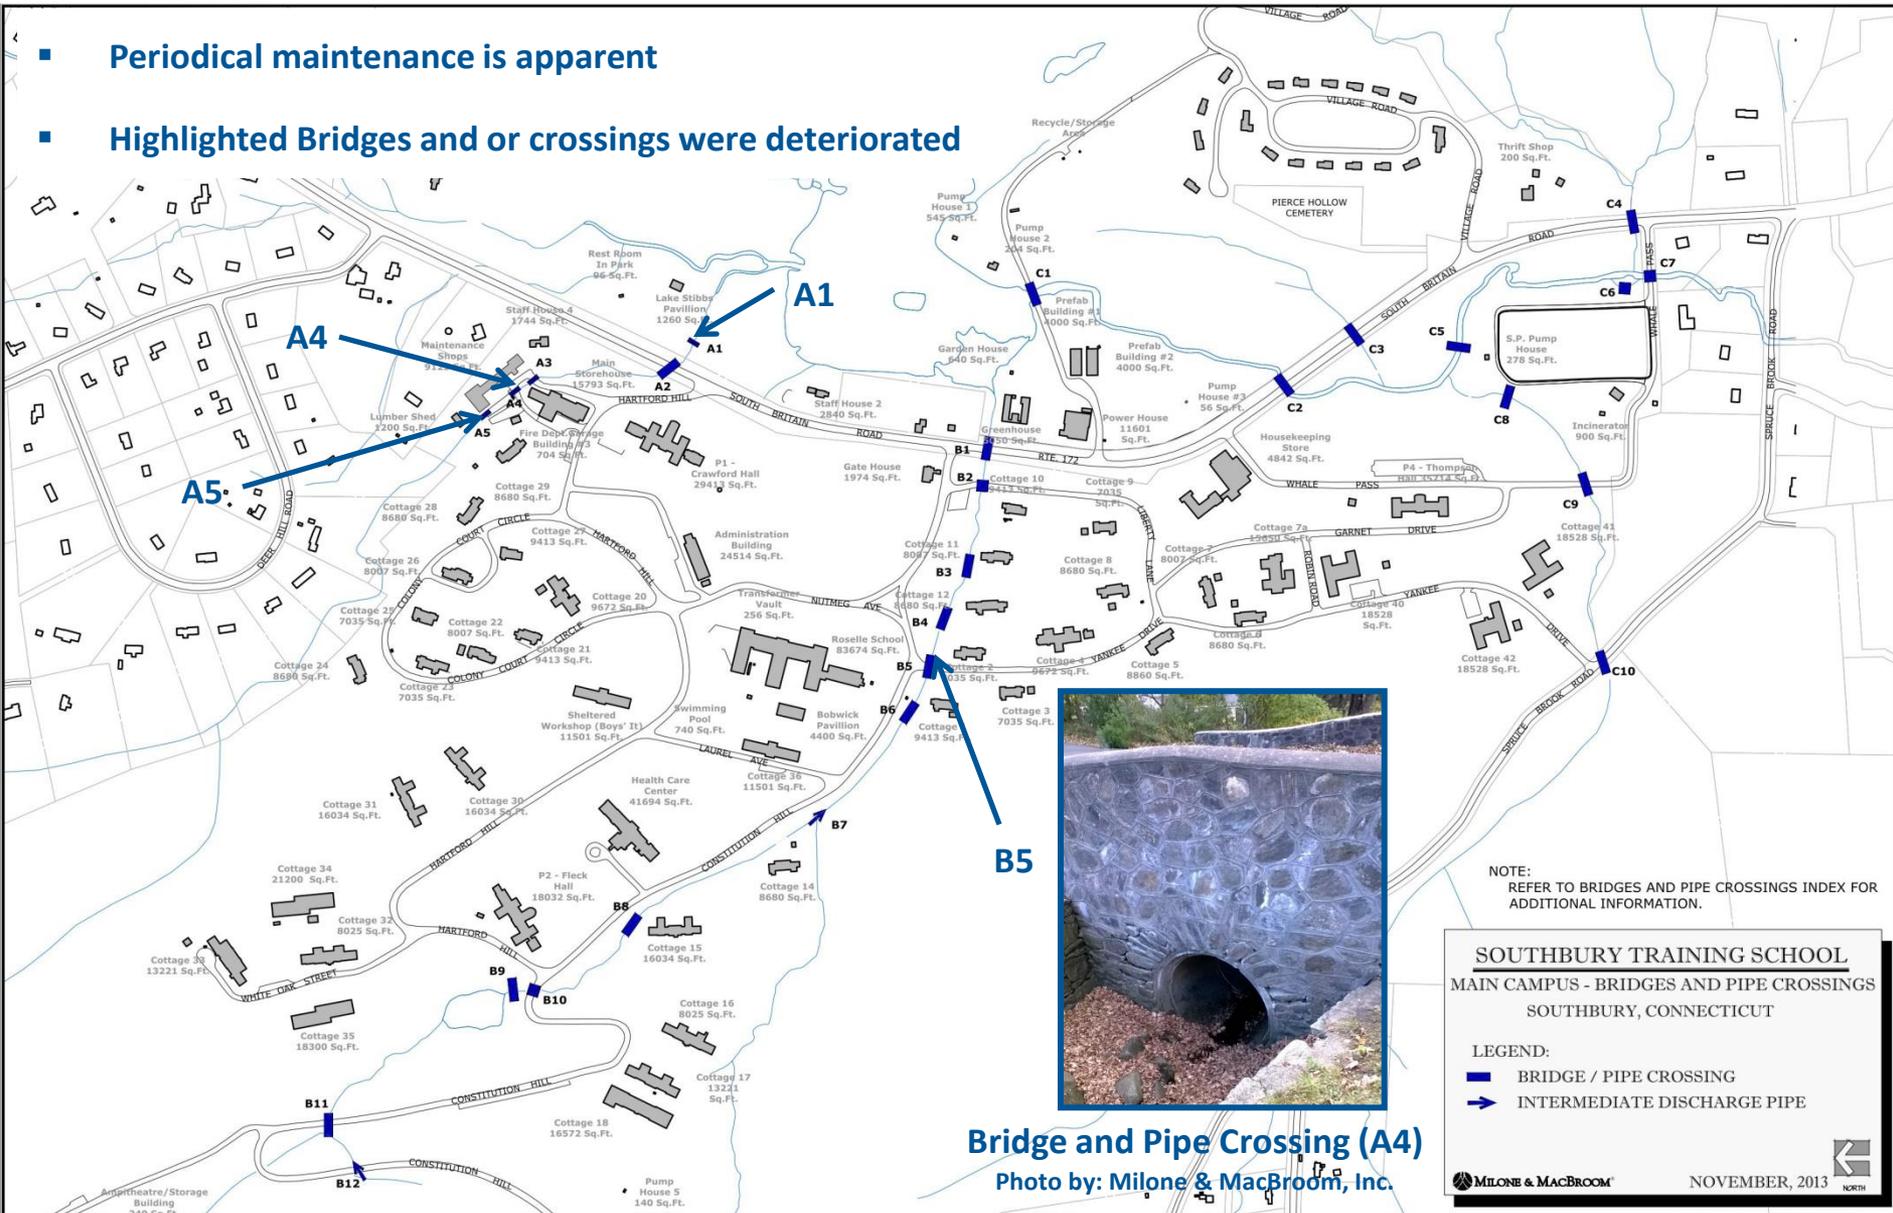
# Bridge and Pipe Crossings

- Periodical maintenance is apparent
- Highlighted Bridges and or crossings were deteriorated

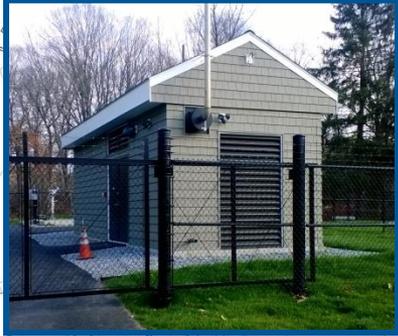
**Pump Station**

- **STS has 180,000 Gallons per Day (GPD) capacity**
- **STS is currently operating at 38% of its total capacity**

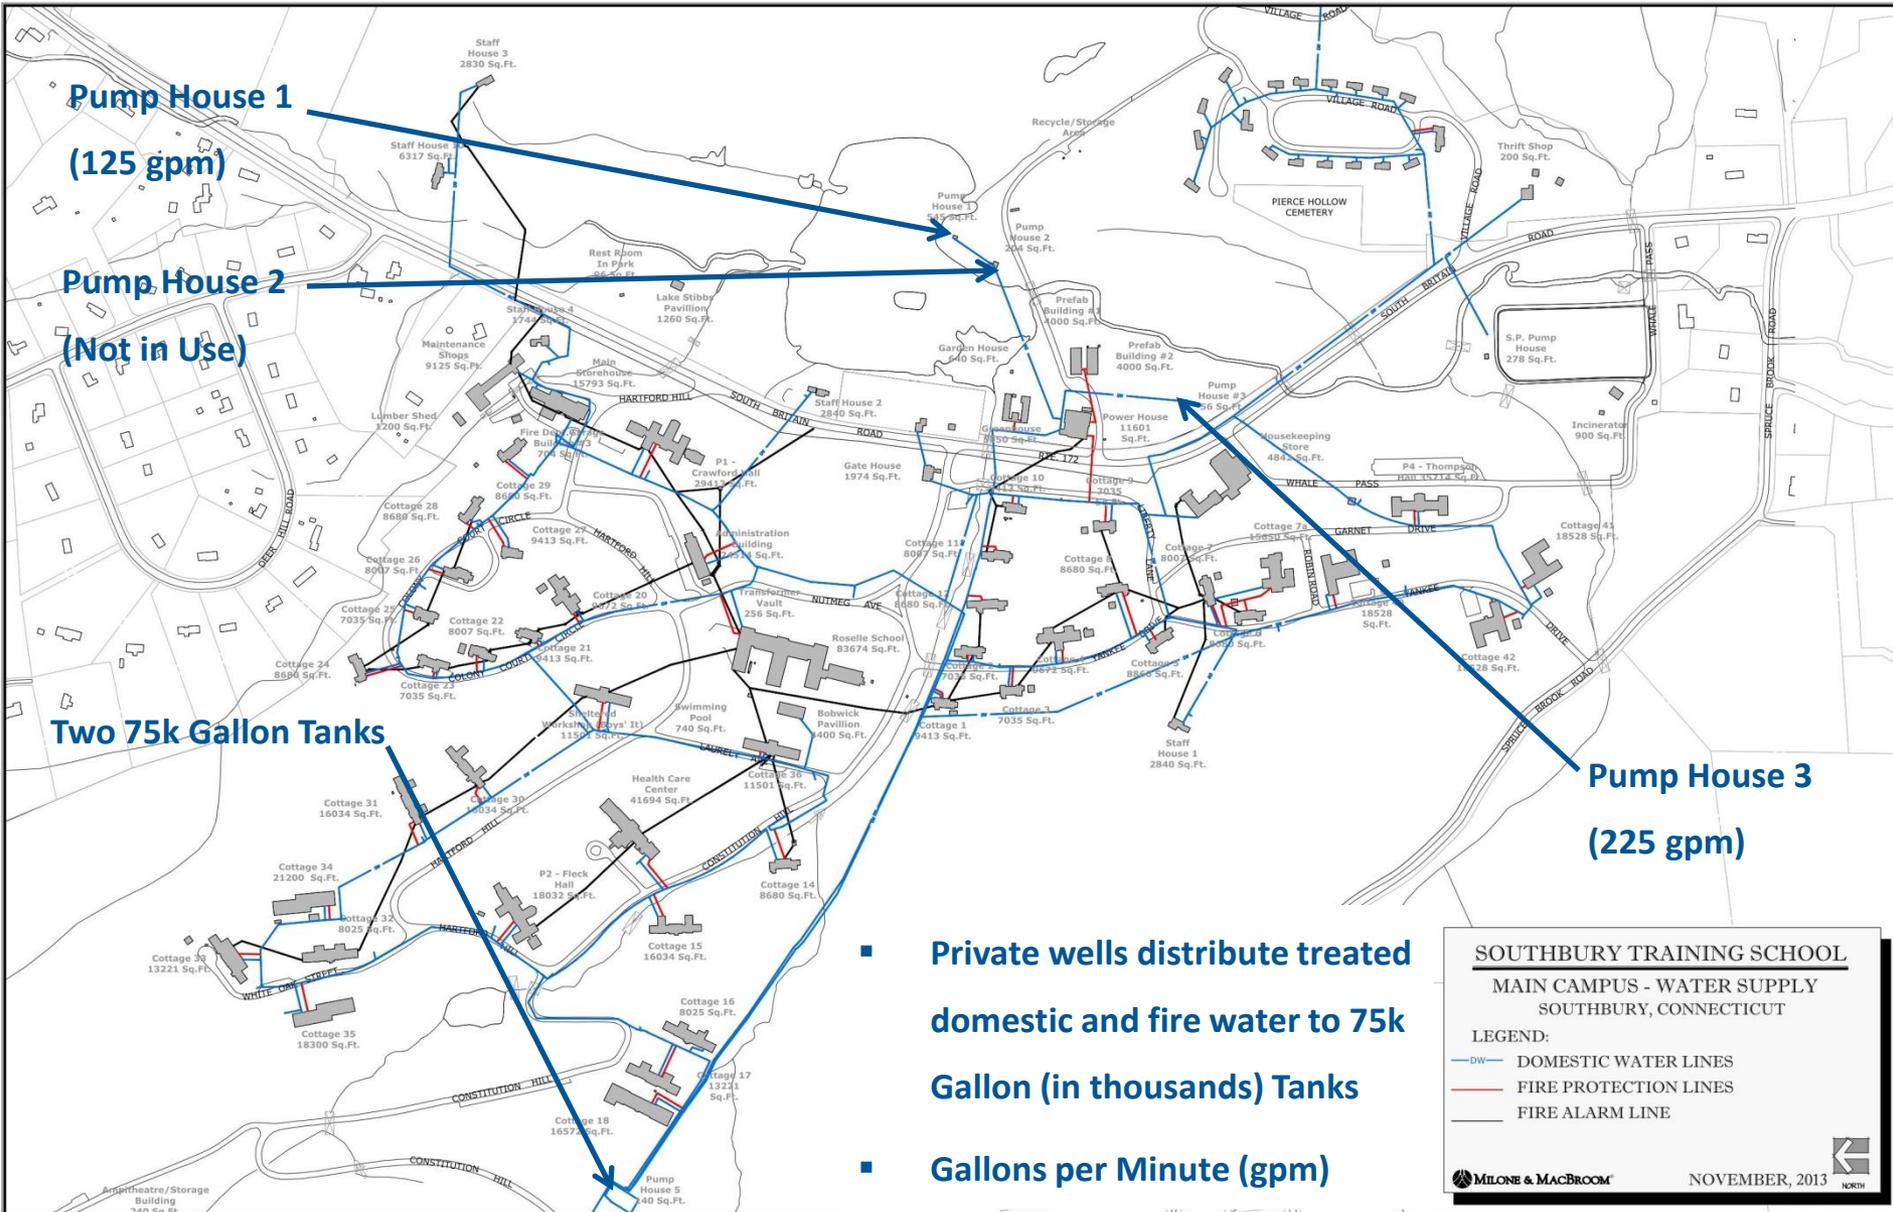
**SOUTHBURY TRAINING SCHOOL**  
**MAIN CAMPUS - WATER SUPPLY**  
**SOUTHBURY, CONNECTICUT**

- Private wells distribute treated domestic and fire water to 75k Gallon (in thousands) Tanks
- Gallons per Minute (gpm)

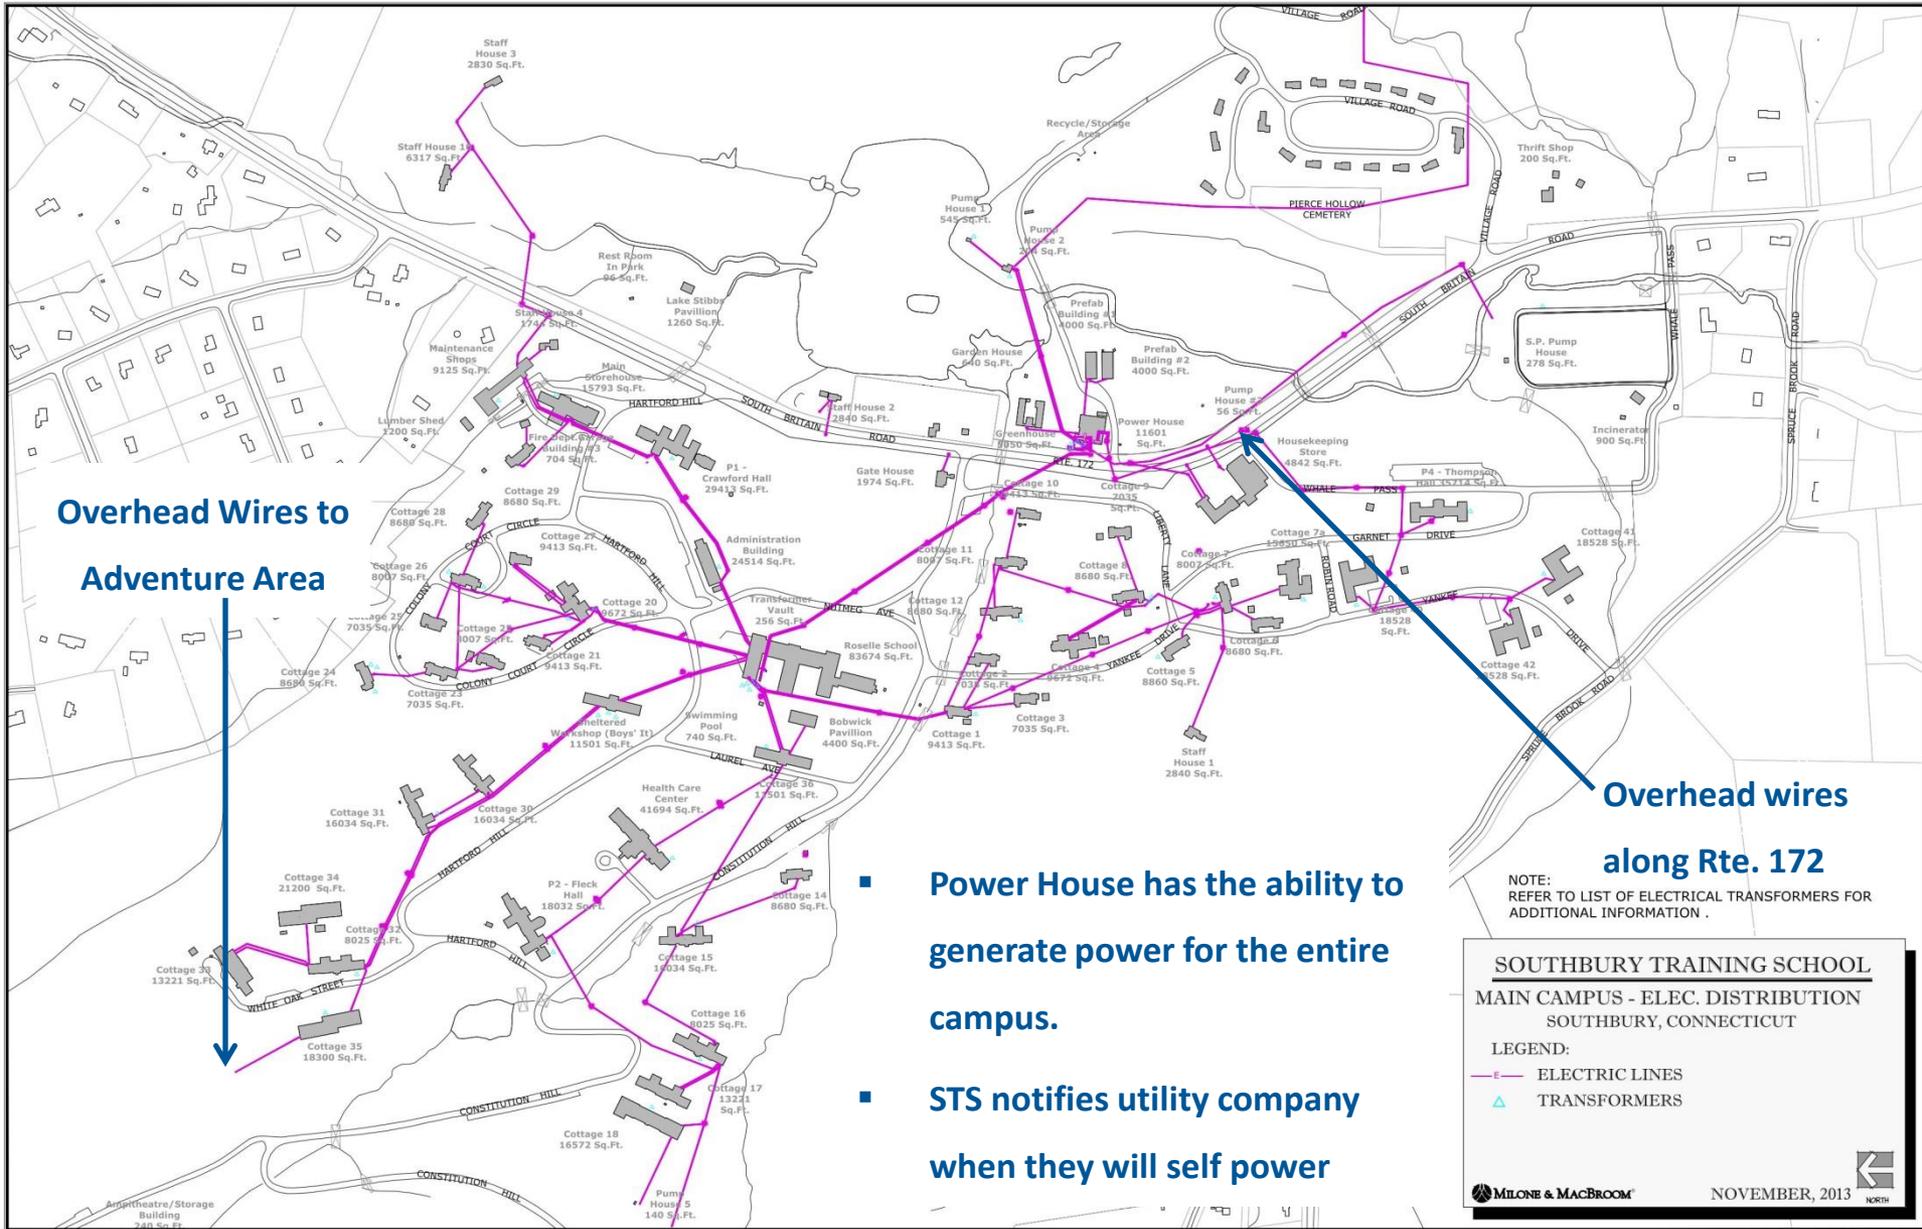
**SOUTHBURY TRAINING SCHOOL**  
**MAIN CAMPUS - ELEC. DISTRIBUTION**  
 SOUTHBURY, CONNECTICUT

**Overhead Wires to Adventure Area**

**Overhead wires along Rte. 172**

- Power House has the ability to generate power for the entire campus.
- STS notifies utility company when they will self power

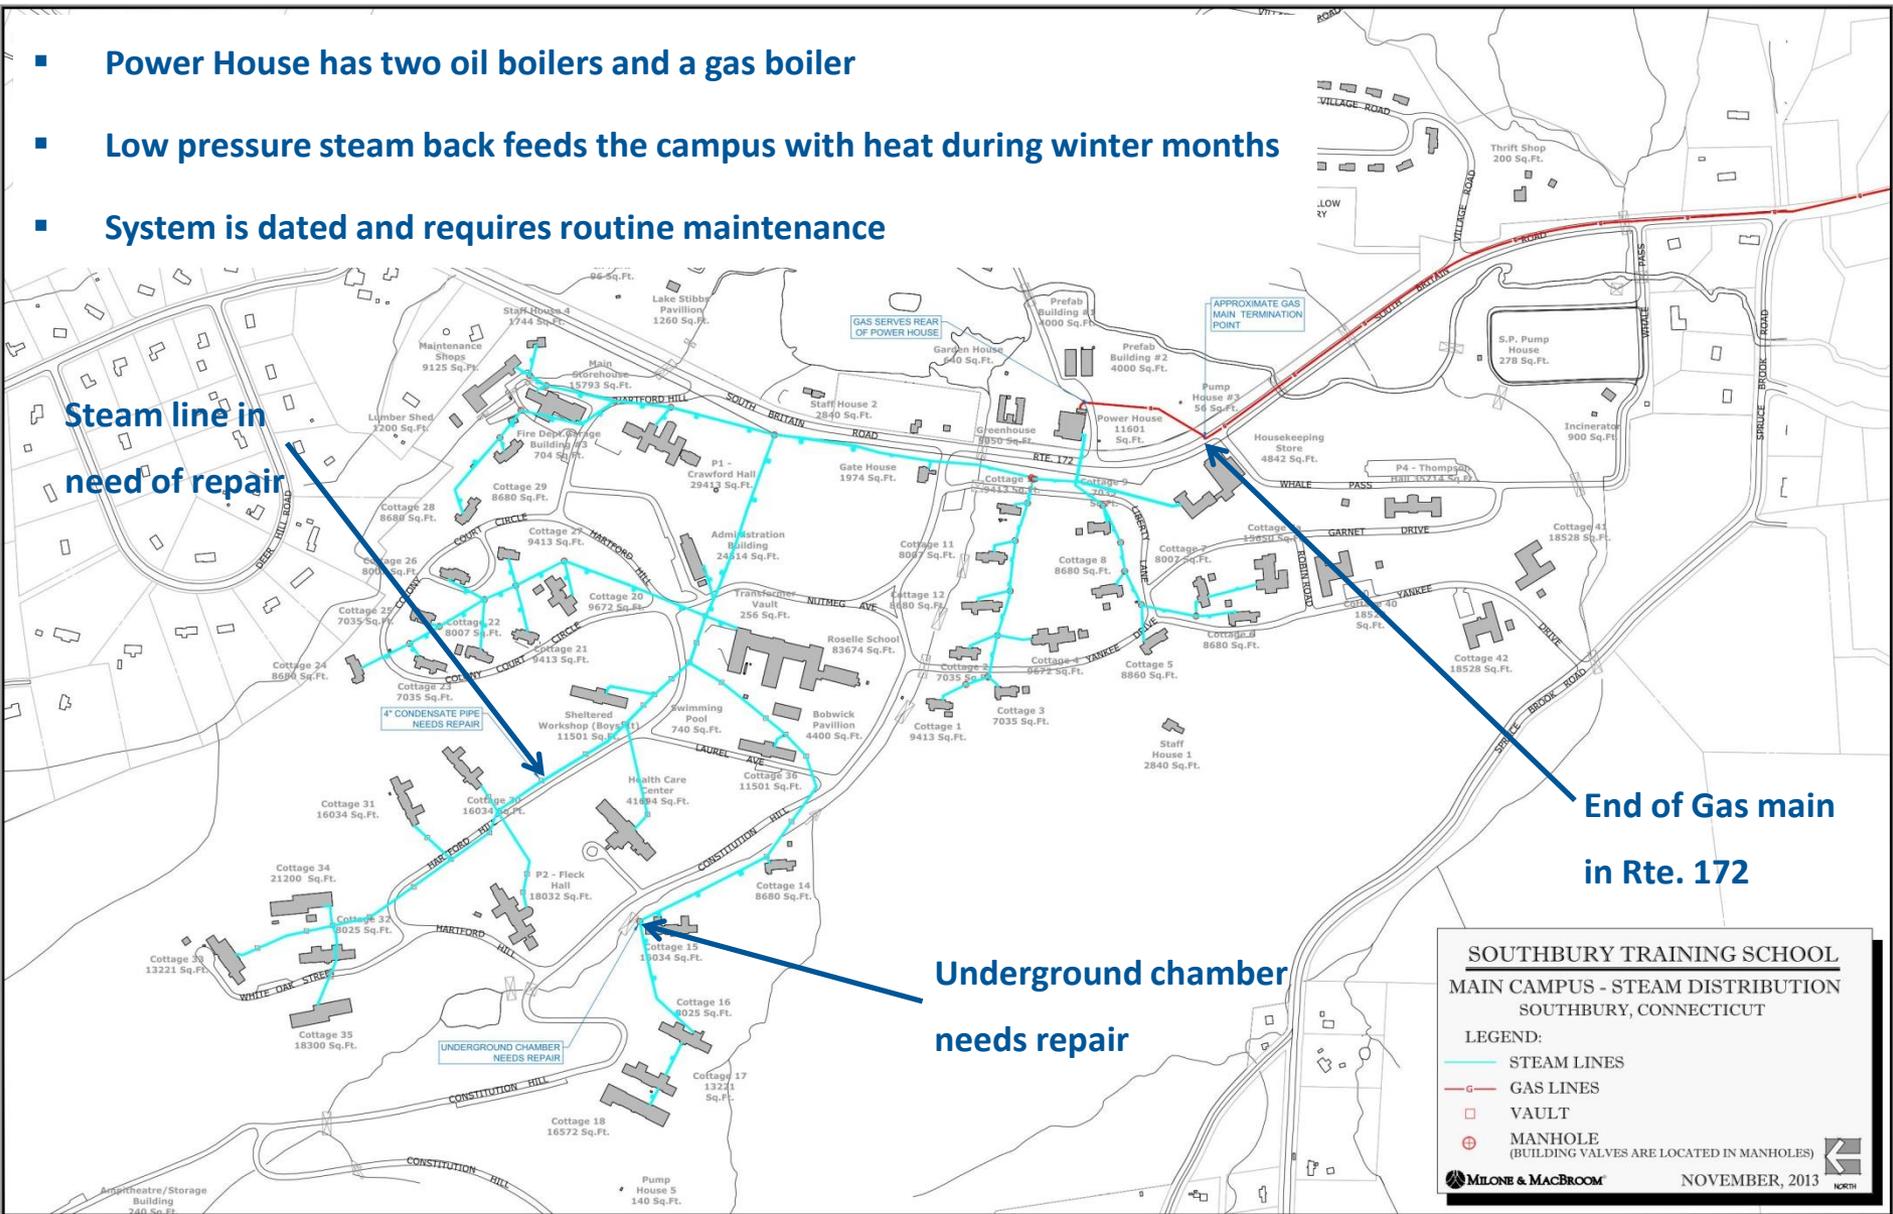
**SOUTHURY TRAINING SCHOOL**  
MAIN CAMPUS - STEAM DISTRIBUTION  
SOUTHURY, CONNECTICUT

- Power House has two oil boilers and a gas boiler
- Low pressure steam back feeds the campus with heat during winter months
- System is dated and requires routine maintenance

Steam line in need of repair

End of Gas main in Rte. 172

Underground chamber needs repair

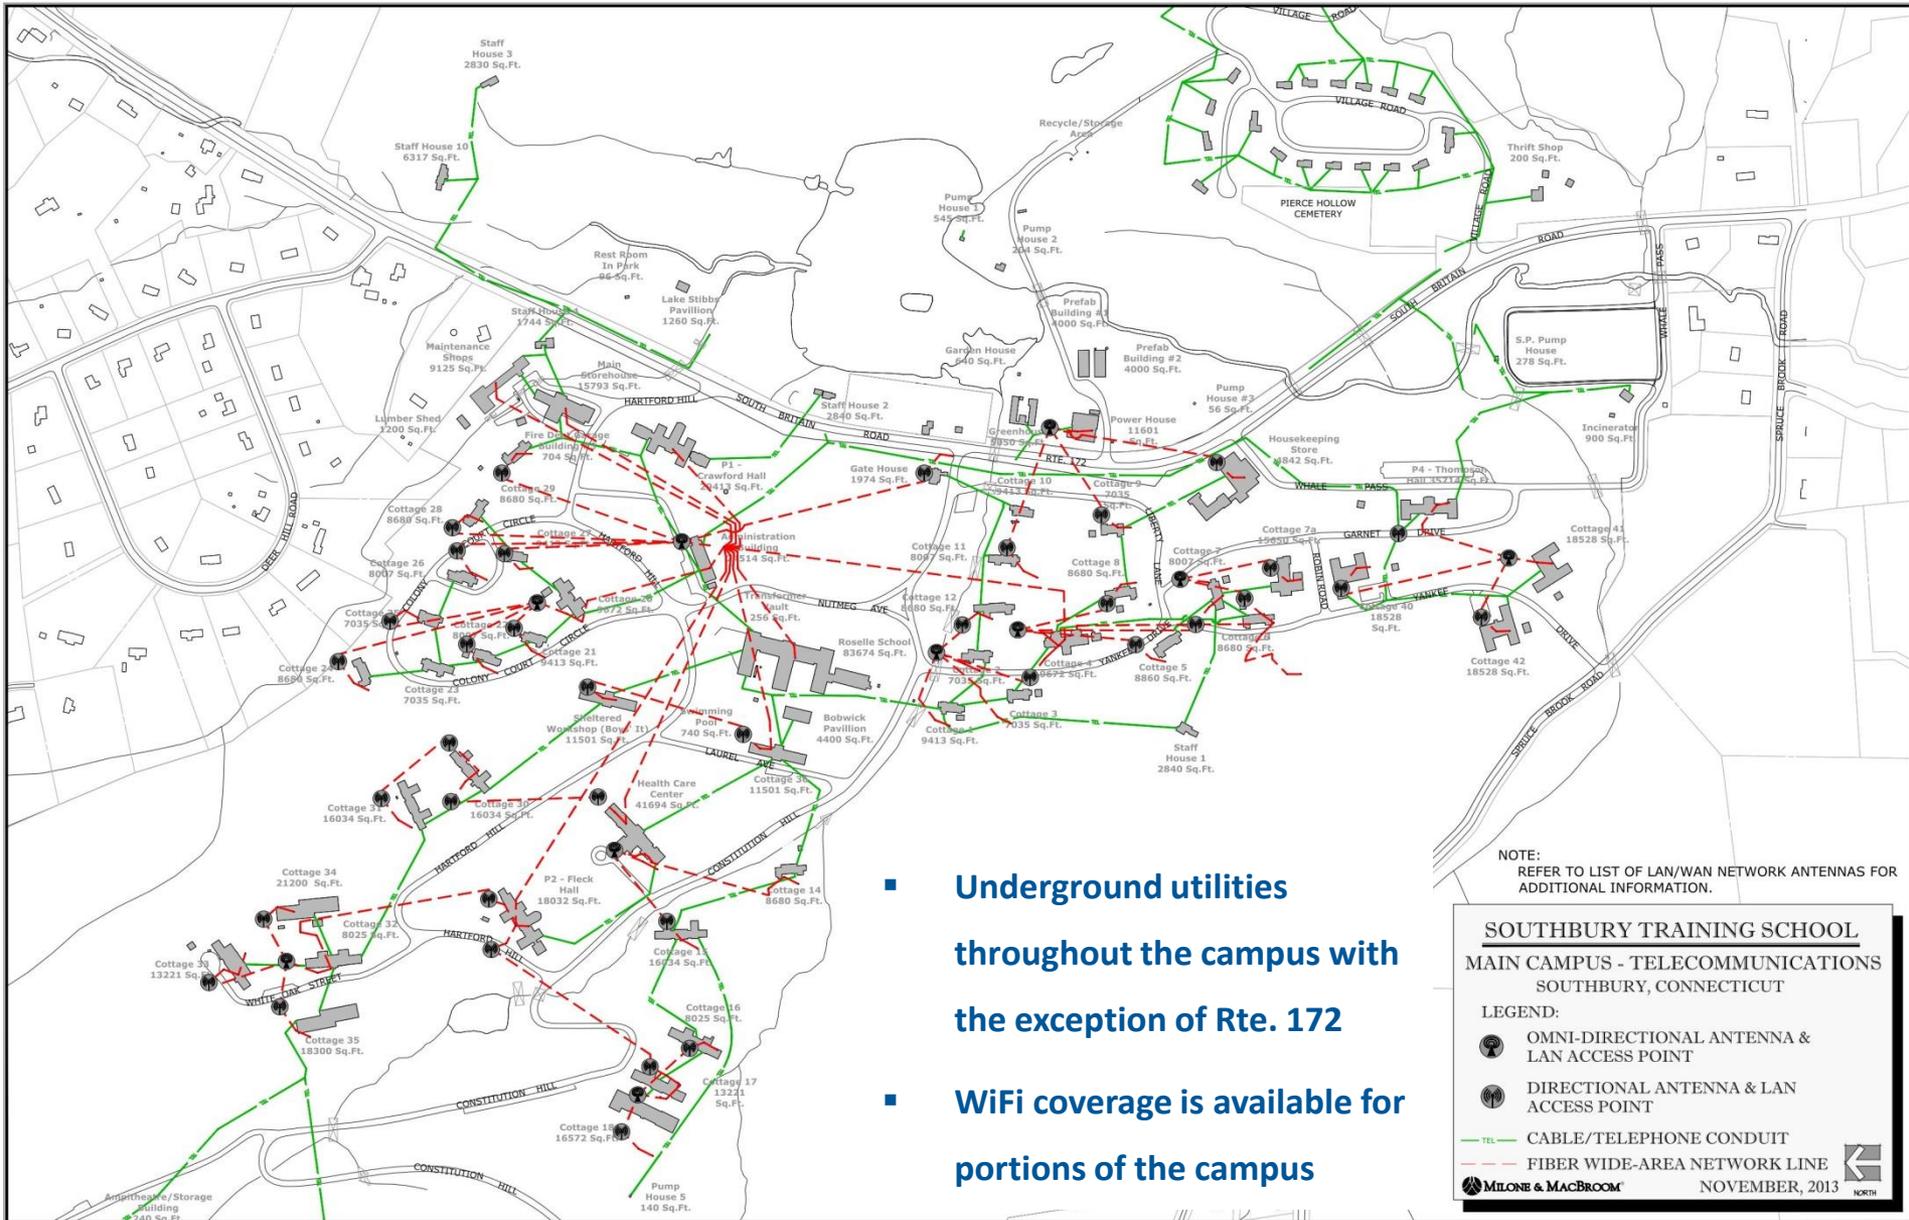
**SOUTHBURY TRAINING SCHOOL  
MAIN CAMPUS - TELECOMMUNICATIONS  
SOUTHBURY, CONNECTICUT**

- **Underground utilities throughout the campus with the exception of Rte. 172**
- **WiFi coverage is available for portions of the campus**
